# The WWII German Heavy Artillery Battery AV 67 of Cleus Foz (Finistère-FR)

**How to cite this paper:** Tomezzoli, G. T. (2017). The WWII German Heavy Artillery Battery AV 67 of CleusFoz (Finistère-FR). *Archaeological Discovery*, 5, 61-78. <https://doi.org/10.4236/ad.2017.52004>

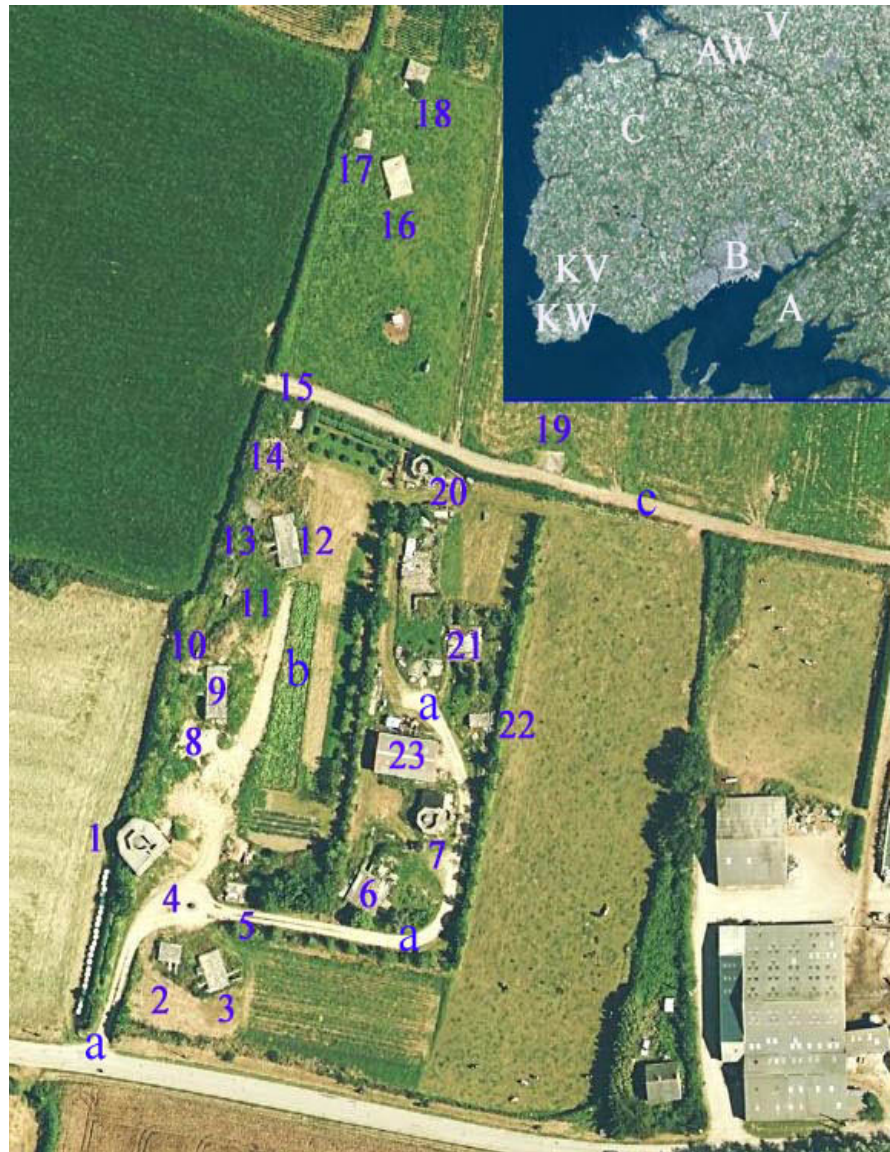
**Figure 1.** CleuzFoz heavy artillery battery-1 R669, 2 - 3 *Vf*s, 4 open emplacement, 5 *Vf*, 6 *M134*, 7 *Flak Vf*; 8 open emplacement, 9 - 13 *Vf*s, 14 open emplacement, 15 - 18 *Vf*s, 19 possible bunker buried in the terrain, 20 *Flak Vf*; 21 *M134*, 22 *Vf*; 23 agricultural shed; a access road, b central area, c external road; A Armorique peninsula; AW Aber Wrach; B Brest; C Cleus Foz battery; KW Keringar Wraz M. K. B. "Graf Spee", KV Keringar Vihan base, V Vougo-Kerizoc radar base (Tomezzoli, 2016) [Geoportail].

The *R669* (48°35'0.16"N, 4°33'3.75"W) (1) (Figure 1 & Figure 2), was similar to those described in previous articles (Tomezzoli & Pottier, 2016a), (Tomezzoli & Pottier, 2016b), except for a hexagonal emplacement on its coverage. The nature of the emplacement is unclear because of the absence of a gun support. It is possible that it hosted either one or more telemeters or a radar Freya for distance measurements, or a light *Flak* gun, like a 2 cm *Flak 30/38/Flakvierling* or 3.7 cm *Flak 18/36/ 37/43*, or a heavier gun, like a 88 mm or a 105 mm gun mounted on its own support. Because of its elevated position, the telemeter would have had an unobstructed field of view and the possible gun would have been effective both against air and field targets. The *R669* combat room probably hosted an *s.F.H.25* rough howitzer or different gun. The *R669* combat room front and rear side apertures were closed, respectively, by a metallic, green coverage provided with a window and a wooden, brown double door, both not of origin; so that the combat room interior was not accessible. However, looking through the window, it was possible to ascertain that it was cluttered by materials. The ammunitions for the gun were stored in an ammunition room inside the *R669*. Because no stair was present on the external concrete structure, the hexagonal emplacement was accessible only through the combat room. The opening of the exhausted combat gas pipe was clearly recognizable on the bunker rear side. The *R669* external concrete structure was in a good preservation state without damages due to combats.

A possible circular open gun emplacement (8) (**Figure 1**) was located about 30 m north from the circular open emplacement (4). It measured about 10 m in diameter. The external circular rail, the metallic plate, the circular rail and the *s.F.H.25* carriage rotation pin were not visible, suggesting that the emplacement was not terminated or not foreseen for an *s.F.H.25* but rather for an 88 mm or 105 mm gun mounted on its own support.

The *Vf*(9) (**Figure 1**), about  $12 \times 6$  m, emerged two meters from the terrain. It was provided with one entrance provided with protection walls. The entrance was obstructed by terrain and vegetation; so that the inspection of the interior was not possible. The presence on its coverage of two chimney conduits suggested that it was intended for hosting one or two groups of soldiers. The emerging *Vf*(9) concrete structure was in a good preservation state without damages due to combats.

The *Vf*(10) (**Figure 1**), about  $5 \times 5$  m, was buried in the terrain. It was provided with one entrance provided with protection walls. The entrance was obstructed by terrain and vegetation; so that the inspection of its interior was not possible. The absence on its coverage of conduits for chimneys, suggested that it was intended for storing materials for the gun at the open emplacement (8).

The *Vf*(11) (**Figure 1**), about  $4 \times 4$  m, was buried in the terrain. It was provided with two entrances, both with a concrete access ramp and protection walls. The entrances were obstructed by terrain and vegetation; so that the inspection of its interior was not possible. Notwithstanding its reduced dimensions, its location in the middle of the bunker and emplacements 1 - 5, 8 - 10, 12 - 15 (**Figure 1**) suggests a possible function of direction of the fire operations of the battery.

The *Vf*(13) (**Figure 1**), about  $4 \times 4$  m, was buried in the terrain. It was similar to *Vf*(11), provided with two entrances, both provided with a concrete access ramp and protection walls. The ramps were aligned with those of *Vf*(11). The entrances were obstructed by terrain and vegetation; so that the inspection of its interior was not possible.

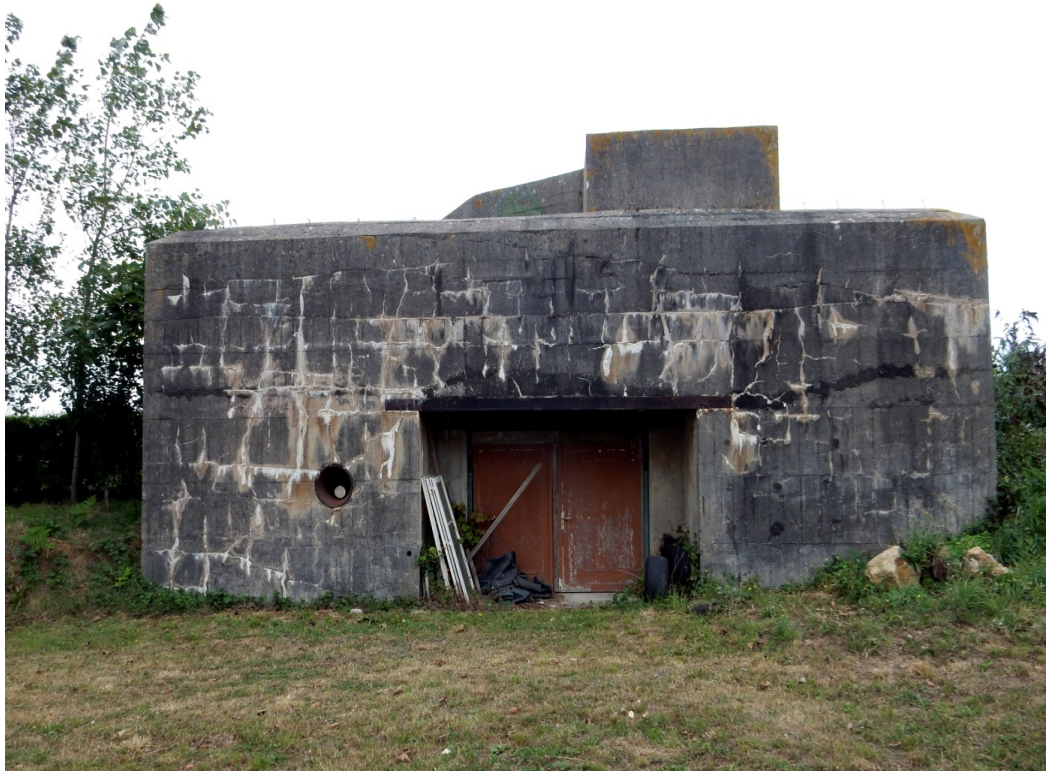
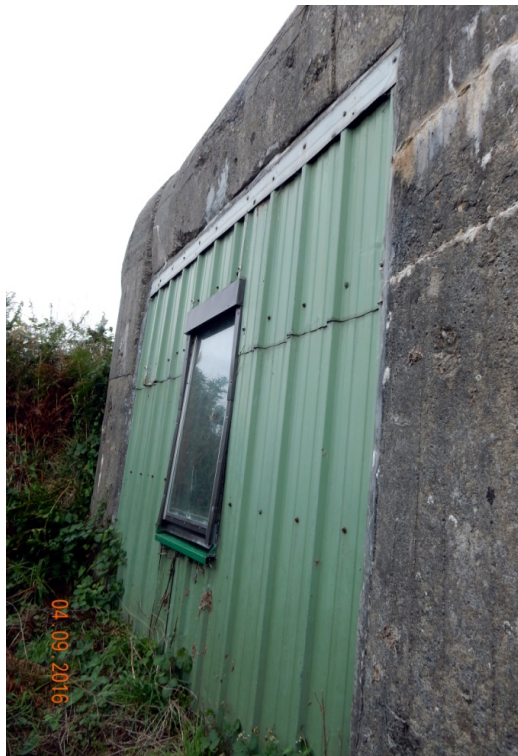
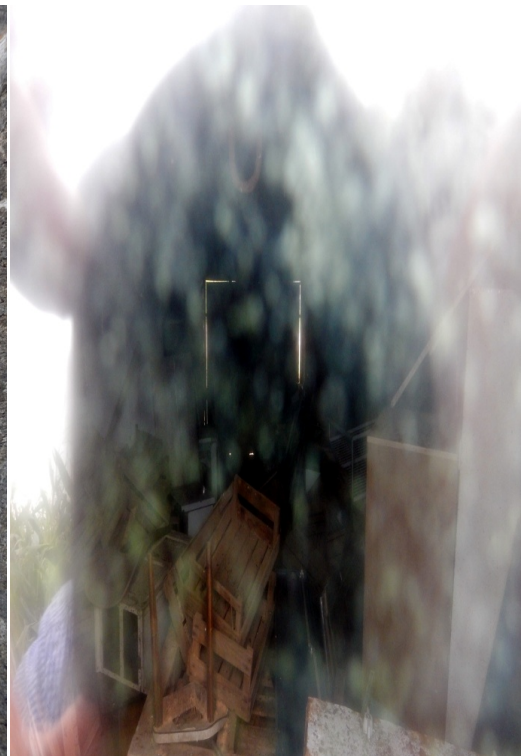
**Figure 2.** R669-(1) rear side opening of the combat room closed by a wooden, brown double door, not of origin, on the left opening of the exhausted combat gas pipe, (2) front side aperture of the combat room closed by a metallic, green coverage provided with a window, not of origin, (3) combat room interior cluttered by materials, seen through the window.

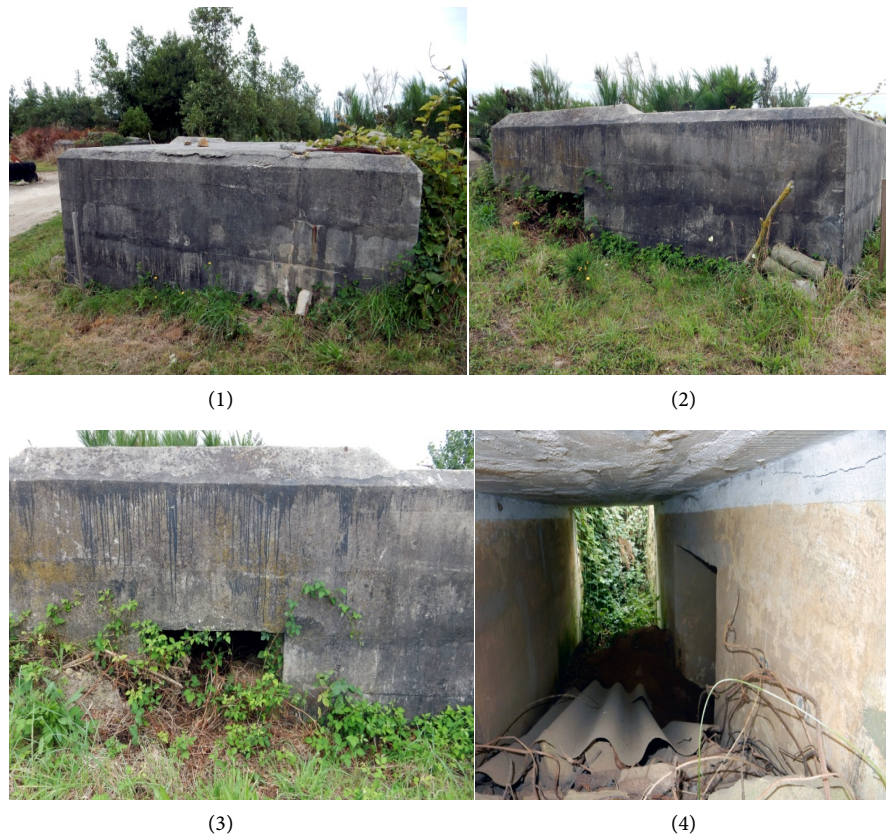
**Figure 3.** *Vf(2)*-(1) side view, (2) side view, (3) entrance obstructed by terrain and vegetation, (4) corridor with interior single room entrance.

The *Vf*(2) (Figure 3), about 6 × 4 m, emerged about two meters from the terrain. It was provided with two entrances, only one of which provided with protection walls. A corridor, preserving its original wall pale ochre painting and ceiling white painting, connected the two entrances with the entrance of an interior single room. The entrances were obstructed by terrain and vegetation; so that the inspection of the interior was not possible. The absence on its coverage of chimney conduits suggested that this bunker was intended for storing materials rather than for hosting a group of soldiers. The emerging *Vf*(2) concrete structure was in a good preservation state without damages due to combats.

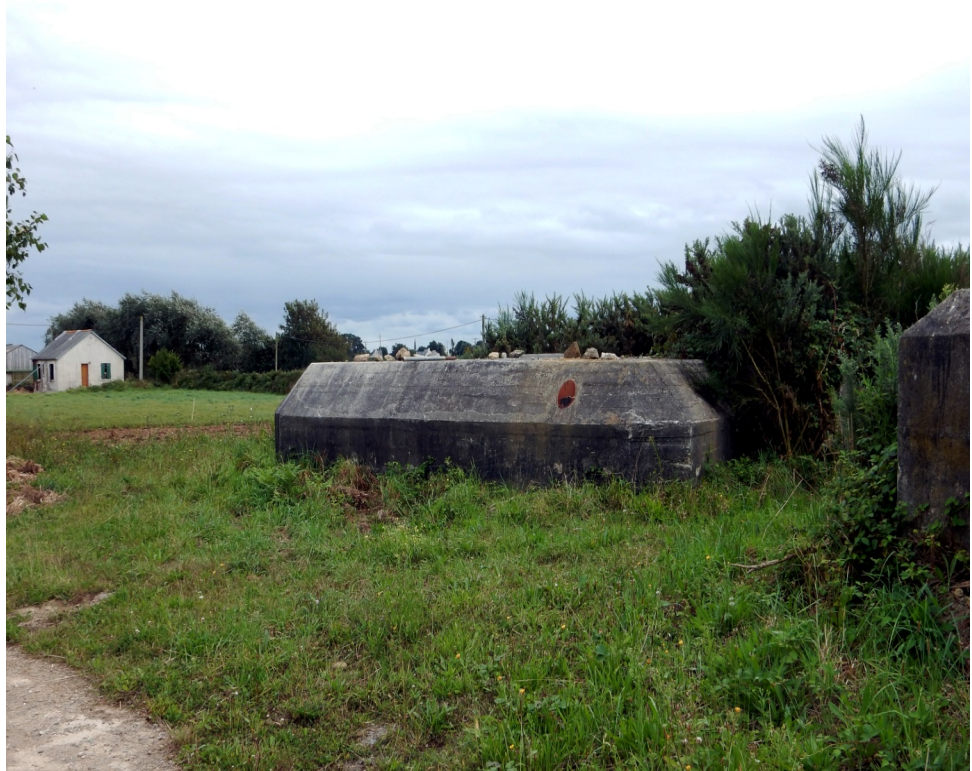
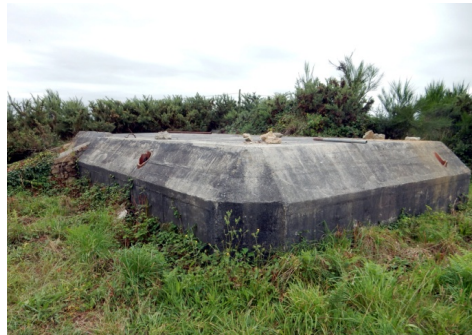
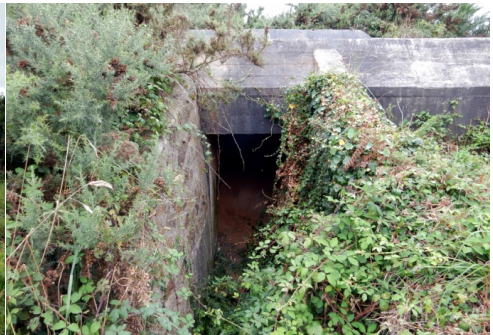
**Figure 4.** *Vf(3)*-(1) side view: on the coverage a chimney conduit, on the left circular open emplacement for *s.F.H.25*, on the right *Vf(2)*, (2) coverage with two chimney conduits, on the left bunker entrance, (3) coverage 1 m thick and entrance obstructed by the vegetation.

The *Vf*(3) (Figure 4), about  $9 \times 6$  m, emerged about two meters from the terrain. It was provided with two entrances, both provided with protection walls. A corridor, preserving its original wall pale ochre painting and ceiling white painting, connected the two entrances with the entrance of an interior single room. The entrances were obstructed by terrain and vegetation; so that the inspection of the interior was not possible. The presence on its coverage of two chimney conduits suggested that it was heated if necessary and therefore intended for hosting one or two groups of soldiers. The emerging *Vf*(3) concrete structure was in a good preservation state without damages due to combats.

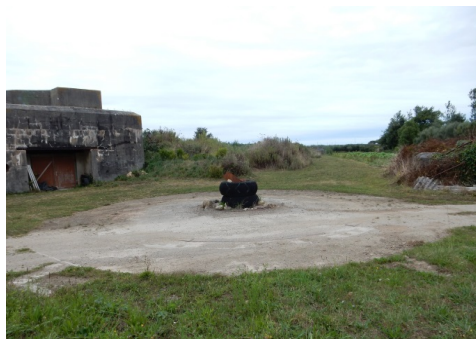
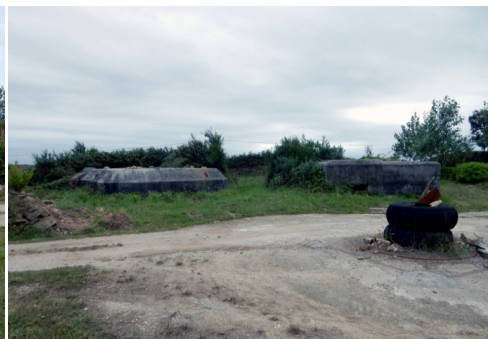
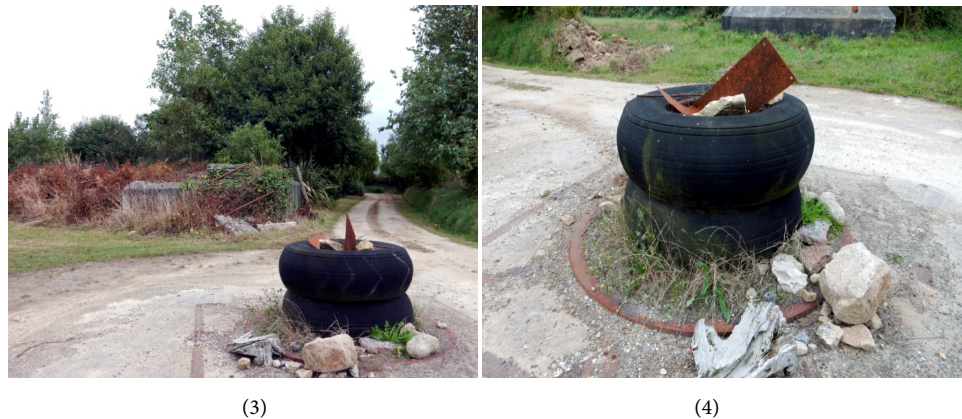
**Figure 5.** Open emplacement (4)-(1) general view: on the left *R669*, on the right *Vf(5)*, (2) on the left *Vf(3)*, side view: on the right *Vf(2)*, (3) side view: on the left *Vf(5)*, on the right access road of the site, (4) square metallic plate provided with raised metallic rim, circular rail and carriage rotation pin covered by two tires.

A circular open emplacement (4) about 10 m in diameter for *s.F.H.25* rough howitzer (**Figure 5**) was located near the *R669*. It was composed by:

- an external circular, metallic rail about 20 cm wide and about 8 m in diameter, flanked by square cavities; and
- an internal, square  $2 \times 2$  m metallic plate provided with a raised metallic rim, a circular rail and, in the middle, a *s.F.H.25* carriage rotation pin, about 40 cm height, covered by two tires. The presence of the rail, the rim and the rotation pin, excluded a use of the open emplacement for a projector or radar.

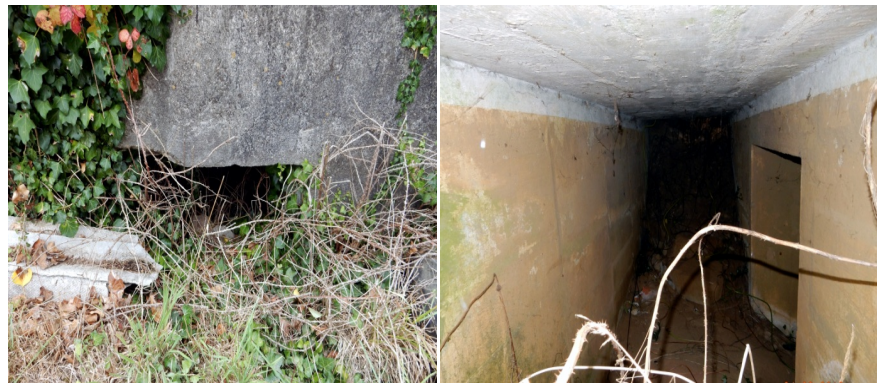
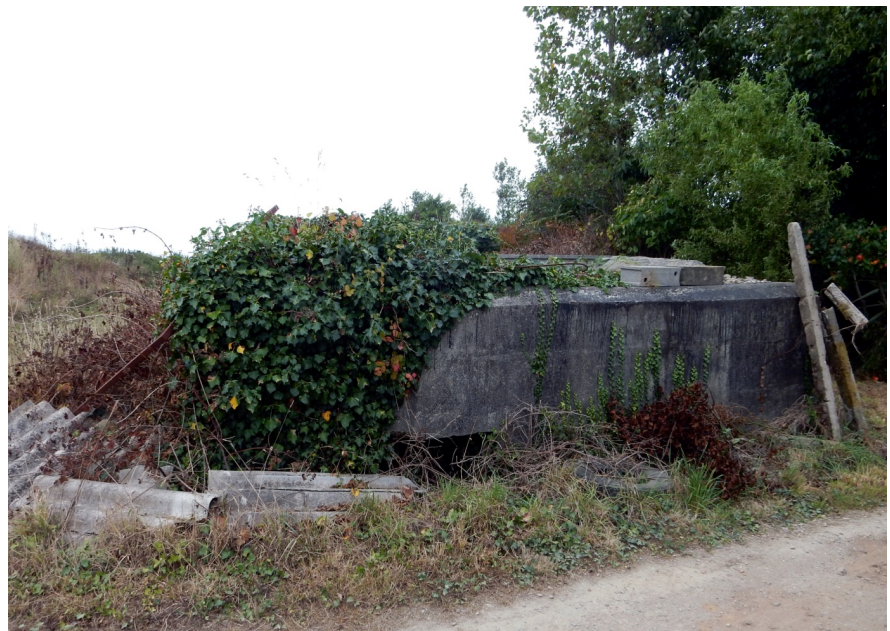
**Figure 6.** Vf(5)-(1) entrance obstructed by terrain and vegetation, (2) internal corridor with interior single room entrance, (3) complete view.

The *Vf(5)* (**Figure 6**), about  $6 \times 4$  m, emerged about two meters from the terrain and was partially covered by vegetation. It was similar to *Vf(2)*, provided with two entrances, both without protection walls. A corridor, preserving its original wall pale ochre painting and ceiling white painting, connected the two entrances with the entrance of an interior single room. The entrances were obstructed by terrain and vegetation; so that the inspection of the interior was not possible. The absence on its coverage of chimney conduits, suggests that this bunker was intended for storing materials. The emerging *Vf(5)* concrete structure was in a good preservation state without damages due to combats.

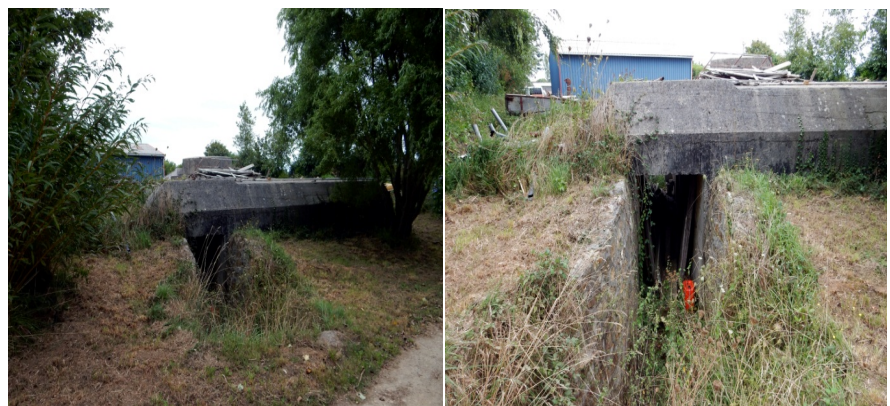
**Figure 7.** M134 (6)-(1) emerging portion with entrance, (2) entrance having protection walls and access ramp obstructed by vegetation, on the foreground the agricultural shed (23).

The *M134* (6) (**Figure 7**),  $11.10 \times 10.80$  m, emerged about one meter from the terrain. It was provided with two entrances, both provided with a concrete access ramp and protection walls. A corridor connected the two entrances with the entrances of two interior ammunition rooms. The bunker entrances were obstructed by terrain and vegetation; so that the inspection of its interior was not possible. Because of its function of storing ammunitions, it was located relatively far from the *R669* and the open emplacement (4) (**Figure 1**). The emerging *M134* (6) concrete structure was in a good preservation state without damages due to combats.

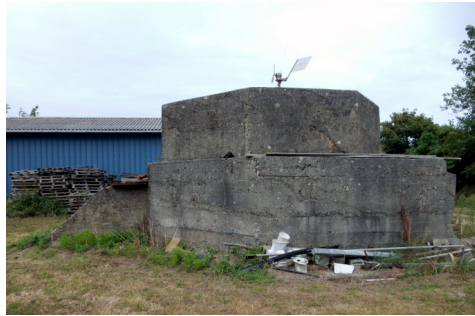
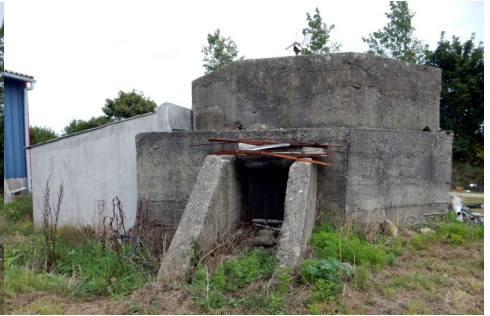
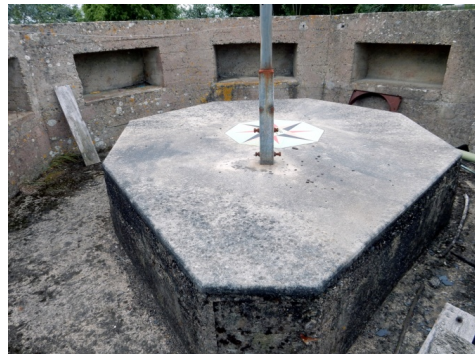
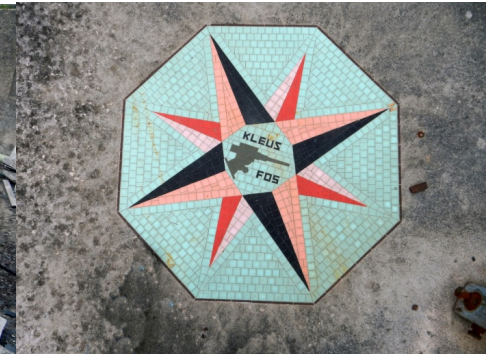
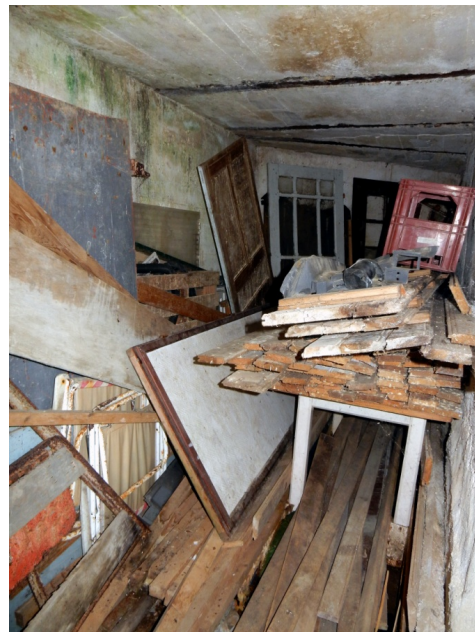
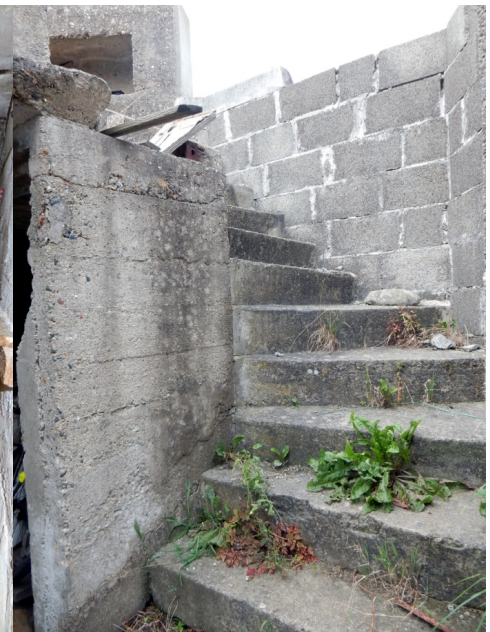
**Figure 8.** *Flak Vf(7)*-(1) concrete, cubic section with superimposed hexagonal gun emplacement, (2) entrance with protective walls, on the left small shed leaning on the bunker, (3) octagonal gun support with mosaic and mast of a small Aeolian generator, on the foreground ammunitions niches, (4) mosaic probably of origin, (5) bunker inside cluttered by materials, (6) staircase to the hexagonal emplacement, (7) front side: annexed concrete room and access stair, on the top the small Aeolian generator, on the right the agricultural shed (23), (8) access ramp to a buried bunker near the *Flak Vf(7)*, (9) *R669* with hexagonal emplacement, (10) *Vf(8)* near to the gun emplacement (8).

The *Flak Vf(7)* (**Figure 8**) ( $48^{\circ}35'0.36''N$ ,  $4^{\circ}33'0.07''W$ ) was formed by a concrete, inferior, cubic section, about  $5 \times 5$  m, supporting a concrete, hexagonal gun emplacement. The gun emplacement was accessible through a spiral staircase provided with a concrete bricks protection wall. On the front side, leaned on the cubic section was a concrete annexed room. Its walls and coverage had a thickness of about 20 cm and a portion of them collapsed by structural reasons. On the rear side was the entrance provided with protection walls. The bunker inside was cluttered by materials and apparently all the original bunker furniture disappeared. The hexagonal gun emplacement preserved the ammunition niches and a concrete octagonal gun support. On the support no joint for fixing a gun, but rather a mosaic, probably of origin, showing an anti-aircraft gun, probably an 88 mm or a 105 mm gun with the inscription *CleusFos* and a mast of a small Aeolian generator. The kind of *Flak* gun hosted in the emplacement is unknown, but probably it was a light one like a 2 cm *Flak 30/38/Flakvierling* or 3.7 cm *Flak 18/36/37/43*. On the external *FlakVf(7)* bunker concrete structure the traces of the boards of the formwork were clearly visible. It was in a substantial good preservation state without damages due to combats, with the only exception of the collapsed portion of the annexed room.

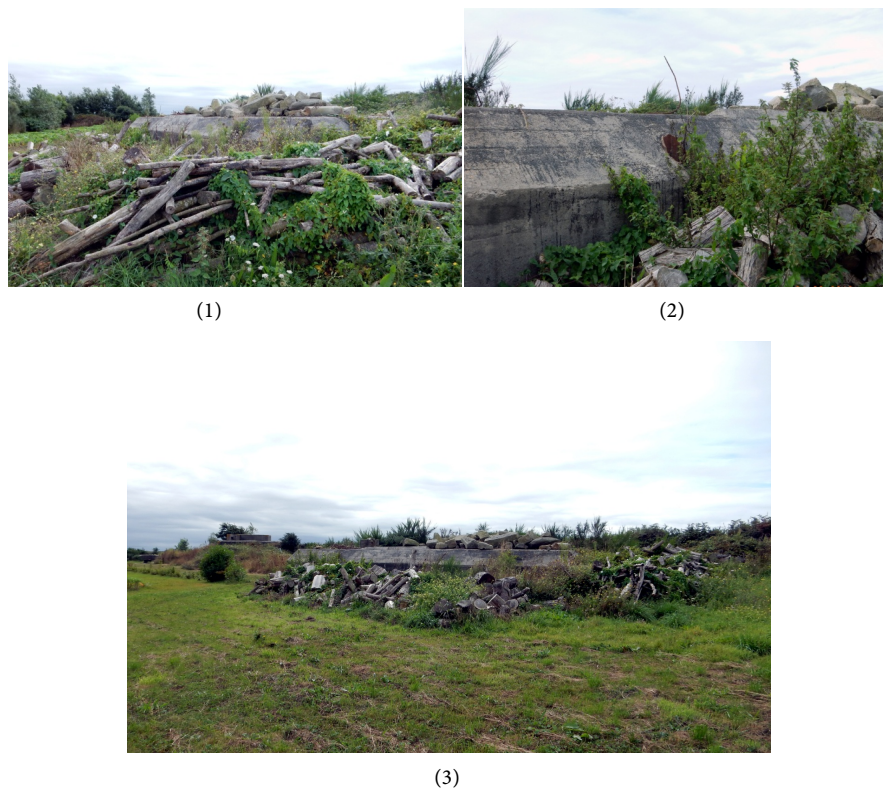
**Figure 9.** *Vf*(12)-(1) side view, (2) coverage with chimney conduit, (3) complete view, on the left *R669*.

The *Vf*(12) (**Figure 9**), about  $12 \times 6$  m, emerged about two meters from the terrain and was partially covered by piles of firewood. It was similar to *Vf*(9), provided with one entrance provided with protection walls. The entrance was obstructed by terrain and vegetation; so that the inspection of its interior was not possible. The presence on its coverage of two chimney conduits suggested that it was intended for hosting one or two groups of soldiers. The emerging *Vf*(12) concrete structure was in a good preservation state without damages due to combats.

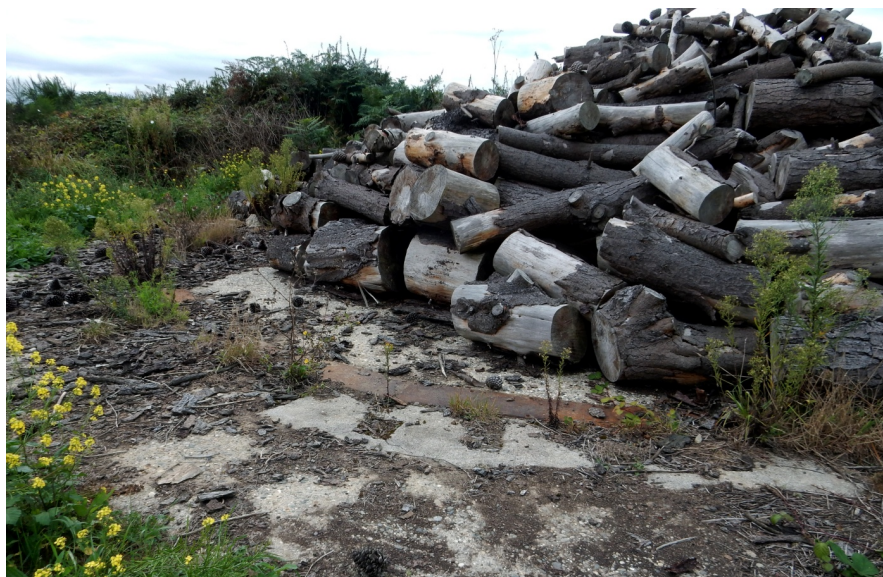
**Figure 10.** Open gun emplacement (14), in the middle external circular rail and square cavities.

A circular open emplacement (14) for *s.F.H.25* rough howitzer (**Figure 10**) was located near the *Vf*(12) and *Vf*(13). It measured about 10 m in diameter. The internal, square  $2 \times 2$  m metallic plate, the circular rail and the *s.F.H.25* carriage rotation pin were covered by a pile of firewood and therefore not visible. Only a portion of the external circular rail, about 20 cm wide, flanked by square

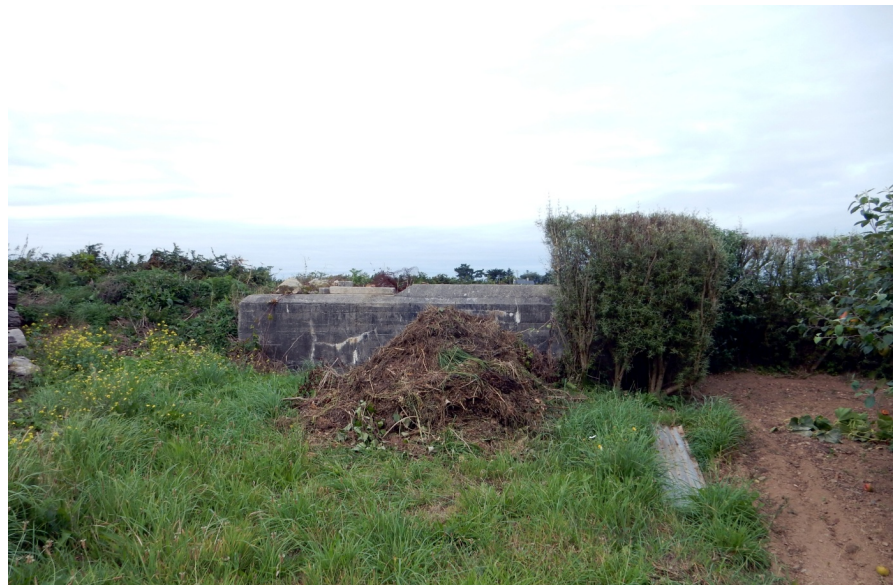
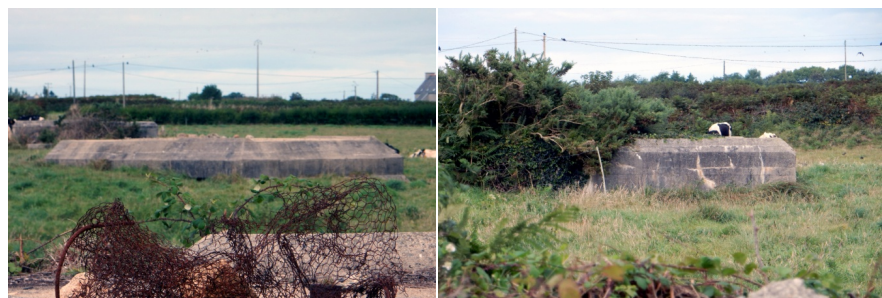
**Figure 11.** Bunkers-(1) *Vf(15)*, (2) *Vf(16)*, on the left *Vf(17)* and *Vf(18)*, (3) *Vf(17)*.

The *Vf*(15) (**Figure 1** and **Figure 11**), about  $5 \times 5$  m, emerged about two meters from the terrain and was partially covered by vegetation. Its entrance/s did not emerge from the terrain; so that the inspection of its interior was not possible. The absence on its coverage of chimney conduits suggested that it was intended for storing materials for the *s.F.H.25* rough howitzer at the open emplacement (14). The emerging *Vf*(15) concrete structure was in a good preservation state without damages due to combats.

The *Vf*(16) (**Figure 1** and **Figure 11**), about  $9 \times 6$  m, emerged about two meters from the terrain. It was similar to *Vf*(3), its entrances were obstructed by terrain and vegetation; so that the inspection of its interior was not possible. It was probably intended for hosting one or two groups of soldiers. The emerging *Vf*(16) concrete structure was in a good preservation state without damages due to combats.

The *Vf*(17) (**Figure 1** and **Figure 11**), about  $4 \times 4$  m, emerged about two meters from the terrain. It was similar to *Vf*(11) and *Vf*(13), its entrances were obstructed by terrain and vegetation; so that the inspection of its interior was not possible. The emerging *Vf*(17) concrete structure was in a good preservation state without damages due to combats.

The *Vf*(18) (**Figure 1** and **Figure 11**), about  $6 \times 4$  m, emerged about two meters from the terrain and was partially covered by vegetation. It was similar to *Vf* (2), provided with entrances obstructed by terrain and vegetation; so that the inspection of its interior was not possible. The absence on its coverage of chimney conduits, suggested that it was intended for storing materials. The emerging *Vf*(18) concrete structure was in a good preservation state without damages due to combats.

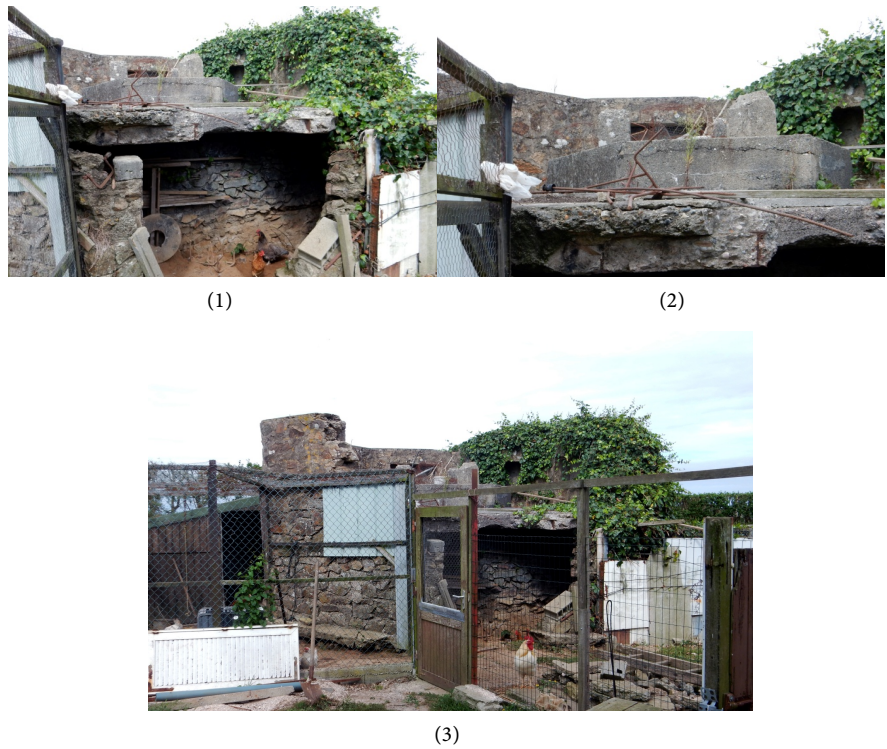
**Figure 12.** *Flak Vf(20)*- (1) circular inferior section in local stone bricks, (2) circular internal room, (3) hexagonal gun emplacement: concrete gun support and on the foreground ammunitions niche.

The *Flak Vf*(20) (**Figure 12**) ( $48^{\circ}35'3''N$ ,  $4^{\circ}33'0.12''W$ ) was integrated in a poultry house. It was similar to *Flak Vf*(7) but of poorer construction. It was built integrally with local stone bricks. A circular inferior section having a circular internal room supported a hexagonal gun emplacement. Its walls and coverage had small thick of about 40 cm and a portion of them collapsed by structural reasons. The hexagonal gun emplacement preserved the concrete gun support and the ammunition niches. The kind of *Flak* gun hosted in the emplacement is unknown, but probably it was a light one like a 2 cm *Flak* 30/38/Flakvierling or 3.7 cm *Flak* 18/36/37/43. The external bunker concrete structure was in a substantial good preservation state, with the exception of the collapsed portion, without damages due to combats.

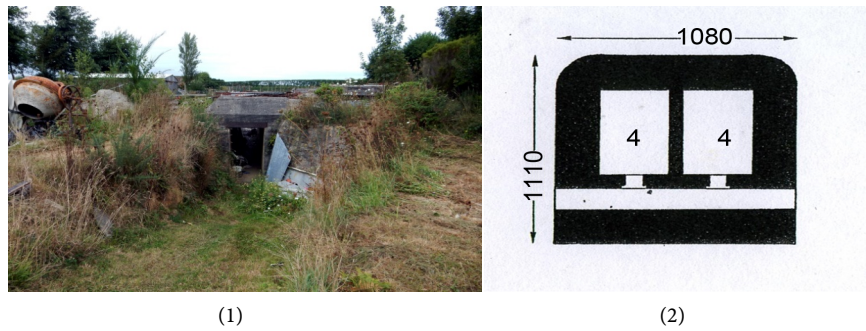
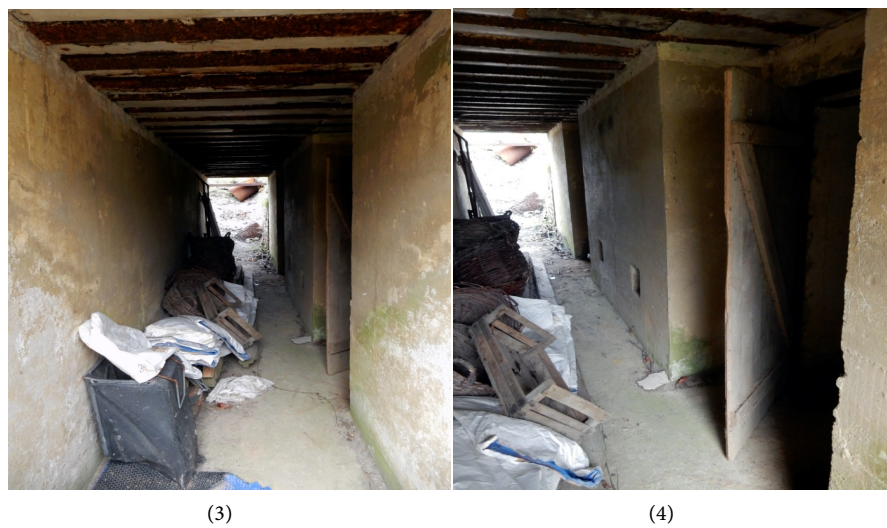
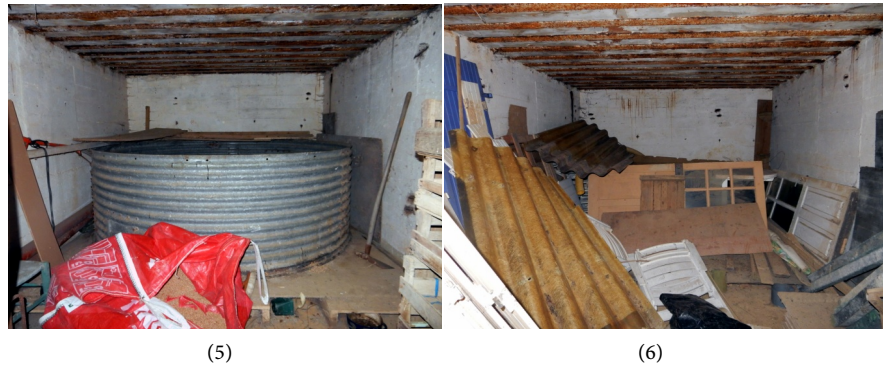
**Figure 13.** *M134* (21)-(1) entrance with concrete access ramp and protection walls, (2) *M134* plan: 4 ammunition room (Rudi 1988), (3) corridor with ammunition room entrances and metallic ceiling, (4) room door, (5) ammunition room, (6) ammunition room.

The *M134* (21) (**Figure 13**),  $11.10 \times 10.80$  m, was buried in the terrain. It was provided with two entrances, both with access ramp and protection walls. A cor-

ridor, preserving its original wall pale ochre painting and metallic ceiling, connected the two entrances with the entrances of two interior ammunition rooms. The corridor entrances were not obstructed; so that the inspection of its interior was possible. Each ammunition room preserved the white painting of the walls, the metallic ceiling and a wooden door probably of origin. All the original room furniture disappeared and their interior was cluttered by materials. Because of its function of storing ammunitions, it was located relatively far from the *R669* and the open emplacements (**Figure 1**).

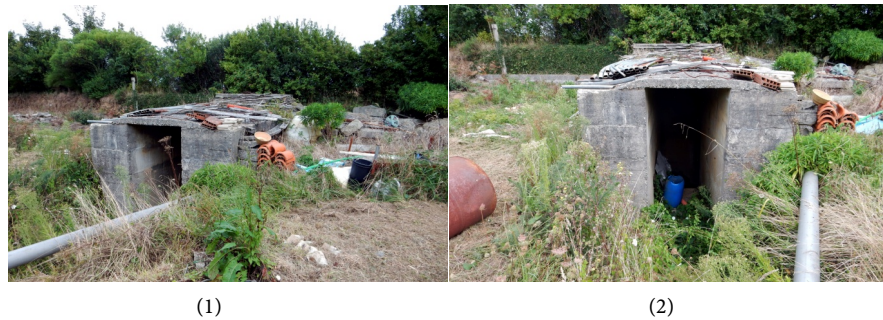
**Figure 14.** *Vf*(22)-(1) entrance with access ramp without protection walls, (2) entrance obstructed by vegetation.

The *Vf(22)* (**Figure 14**), about  $5.5 \times 3.5$  m, was buried in the terrain. It was provided with an entrance provided with access ramp without protection walls. The entrance was obstructed by vegetation, so that the inspection of its interior was not possible. Its coverage had small thick of about 30 cm. Its reduced dimensions and light coverage (**Figure 12**) suggested for it a secondary but important function, like that of water source protection or latrine.
